NAVAL AIR PROPULSION CENTER

NAPC-PE-7

MARCH 1978

EVALUATION OF WATER/FUEL EMULSION CONCEPT FOR TEST CELL SMOKE ABATEMENT

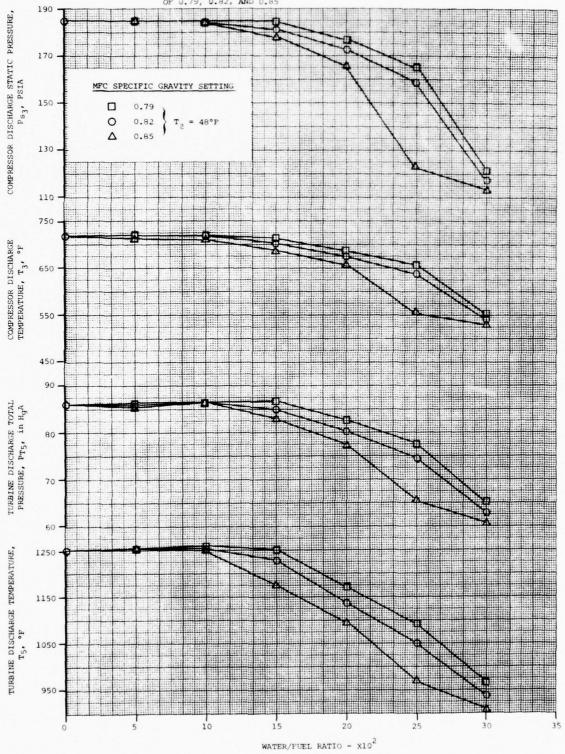
- (4) Figures 8 and 9 show the effect of water concentration on various engine gas generator and control system parameters at intermediate power for three main fuel control specific gravity settings. Figure 8 shows actual uncorrected engine gas generator data of compressor discharge static pressure (P_{S3}), temperature (T₅), turbine discharge total pressure (P_{T5}), and temperature (T₅) versus water/fuel ratio. Figure 9 is a plot of the engine control system parameters of engine fuel flow (W_f), rotor speed (N), and exhaust nozzle area (A_j) versus water concentration. It is evident from these curves that the thrust deterioration beyond the threshold water/fuel ratios shown in Figure 7 is due to steadily decreasing engine fuel flow as water

FIGURE 8. EFFECT OF WATER CONCENTRATION ON ENGINE GAS GENERATOR PERFORMANCE AT INTERMEDIATE POWER AT T₂ = 48°F WITH MFC SPECIFIC GRAVITY SETTINGS OF 0.79, 0.82, AND 0.85

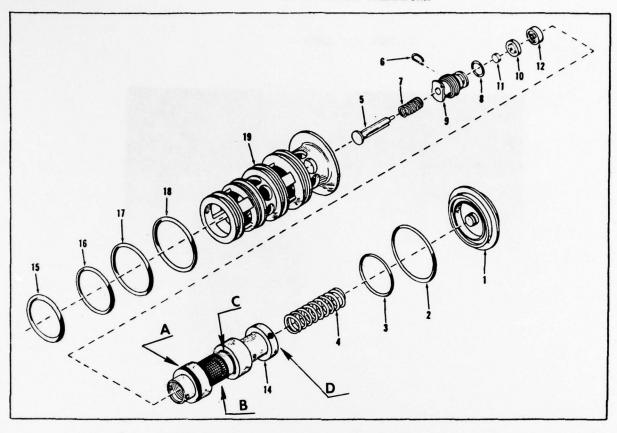
FIGURE 3. AREA C

- 3. One component, the IGV valve plunger assembly (P/N 401620), had land scoring and a small area of intergranular corrosion. The mating sleeve could not be removed from the control body and therefore sleeve inspection was not possible. Photographs of the plunger were taken by PE6 personnel (Jim Newhart); however the pictures have not been received from NADC.

C-Area of Spalling
